MARLIN-ROCKWELL COMPANY
DIVISION OF TRW INC.

M-R-C RESEARCH PROPOSAL NO. 1540
for
GEORGE C. MARSHALL SPACE FLIGHT CENTER
Huntsville, Alabama

"Spin Axis Bearings"

Report - Phase V
Contract No. NAS 8-5441

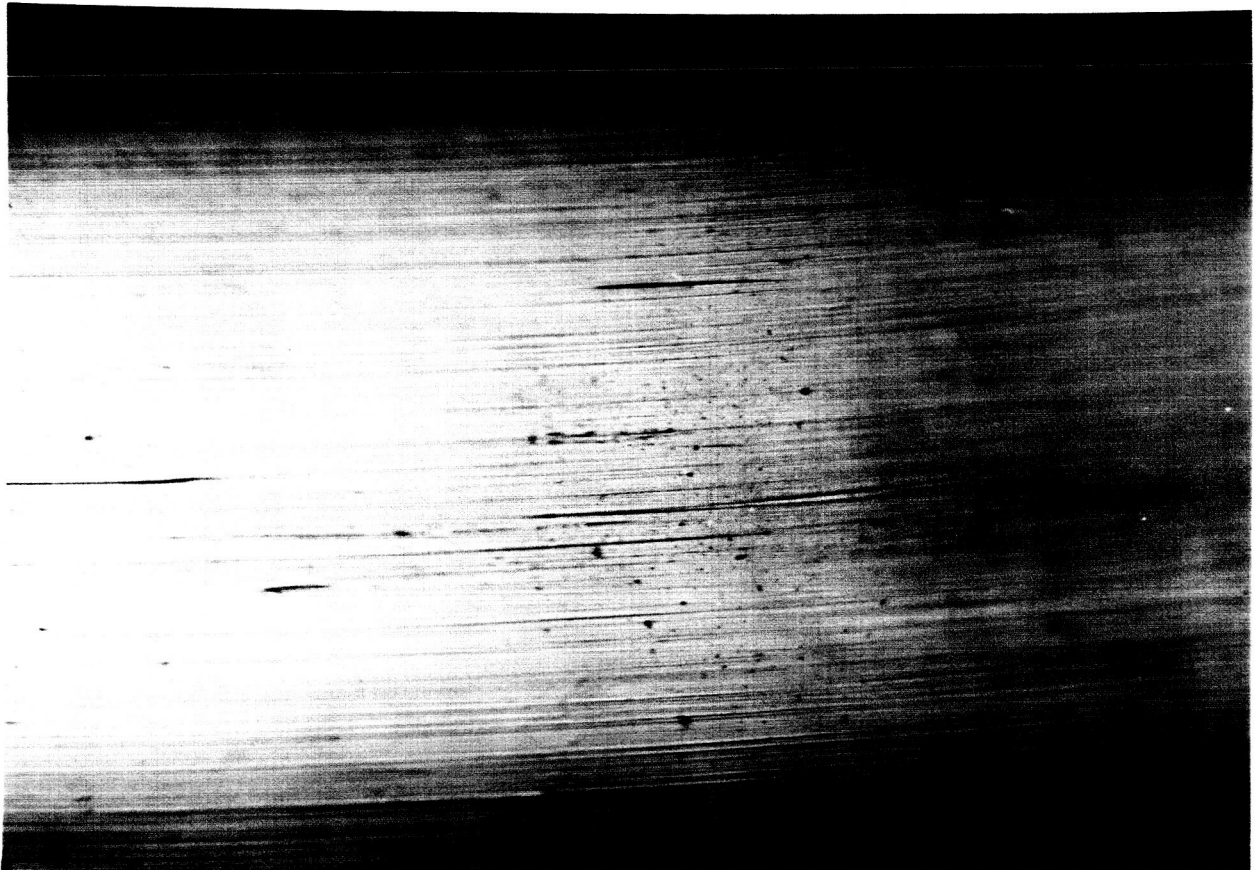
PHOTOGRAPH OF FINISH OF INNER RACE OF
LOT 1, BEARING NO. 1 AT 250X MAGNIFICATION

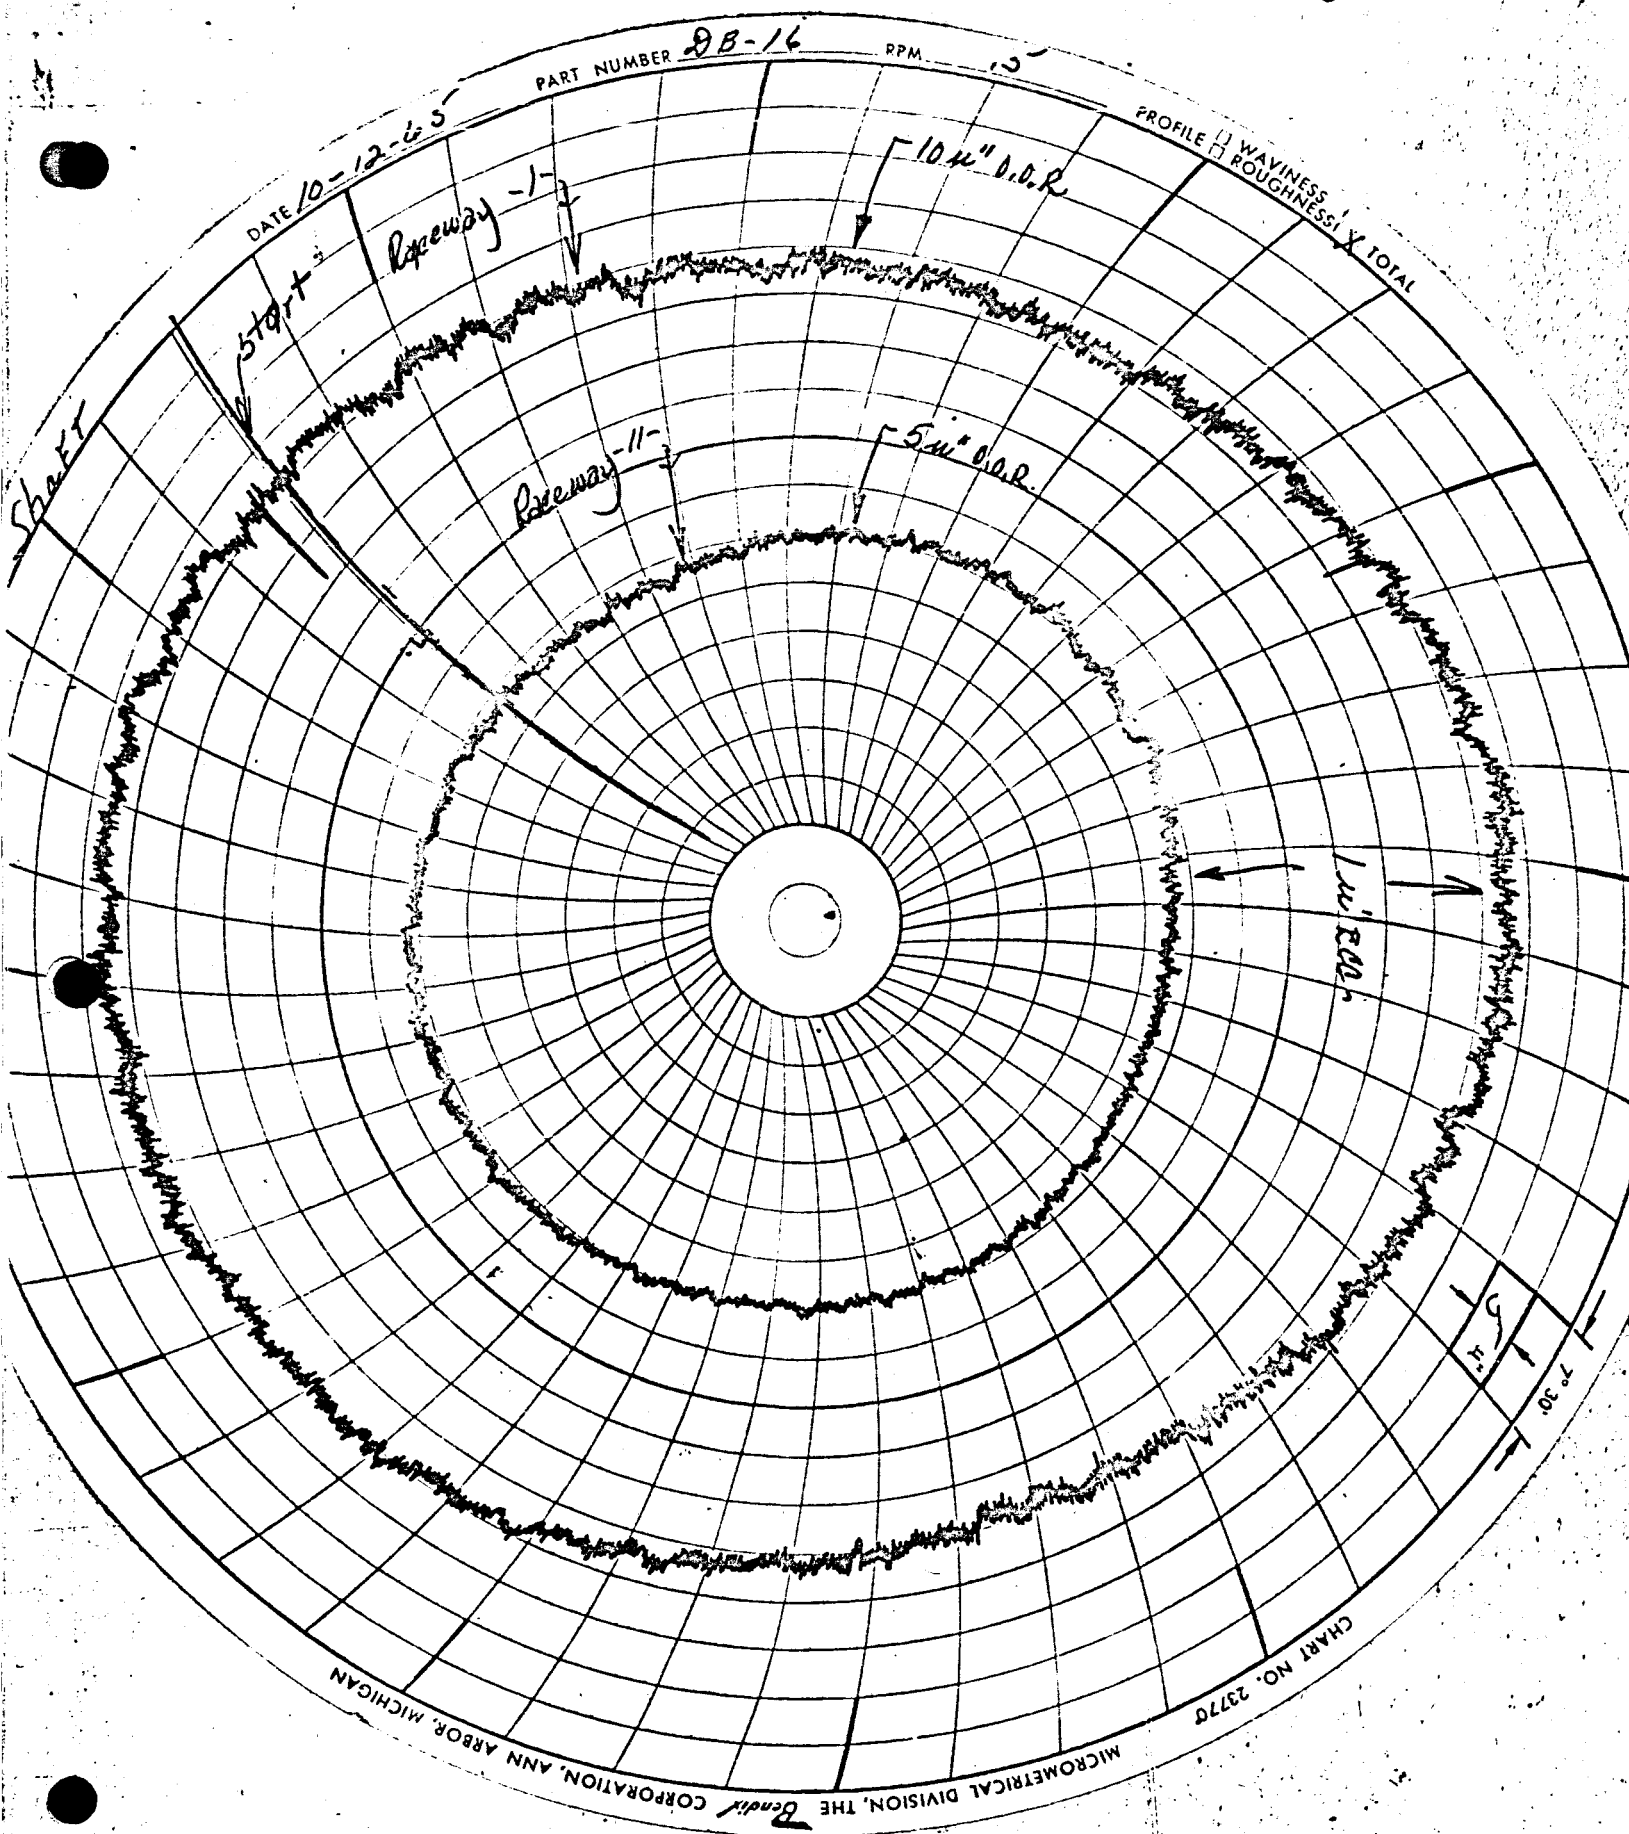
PROFICORDER TRACES OF INNER RACES OF LOT DB, BEARING NO. 16

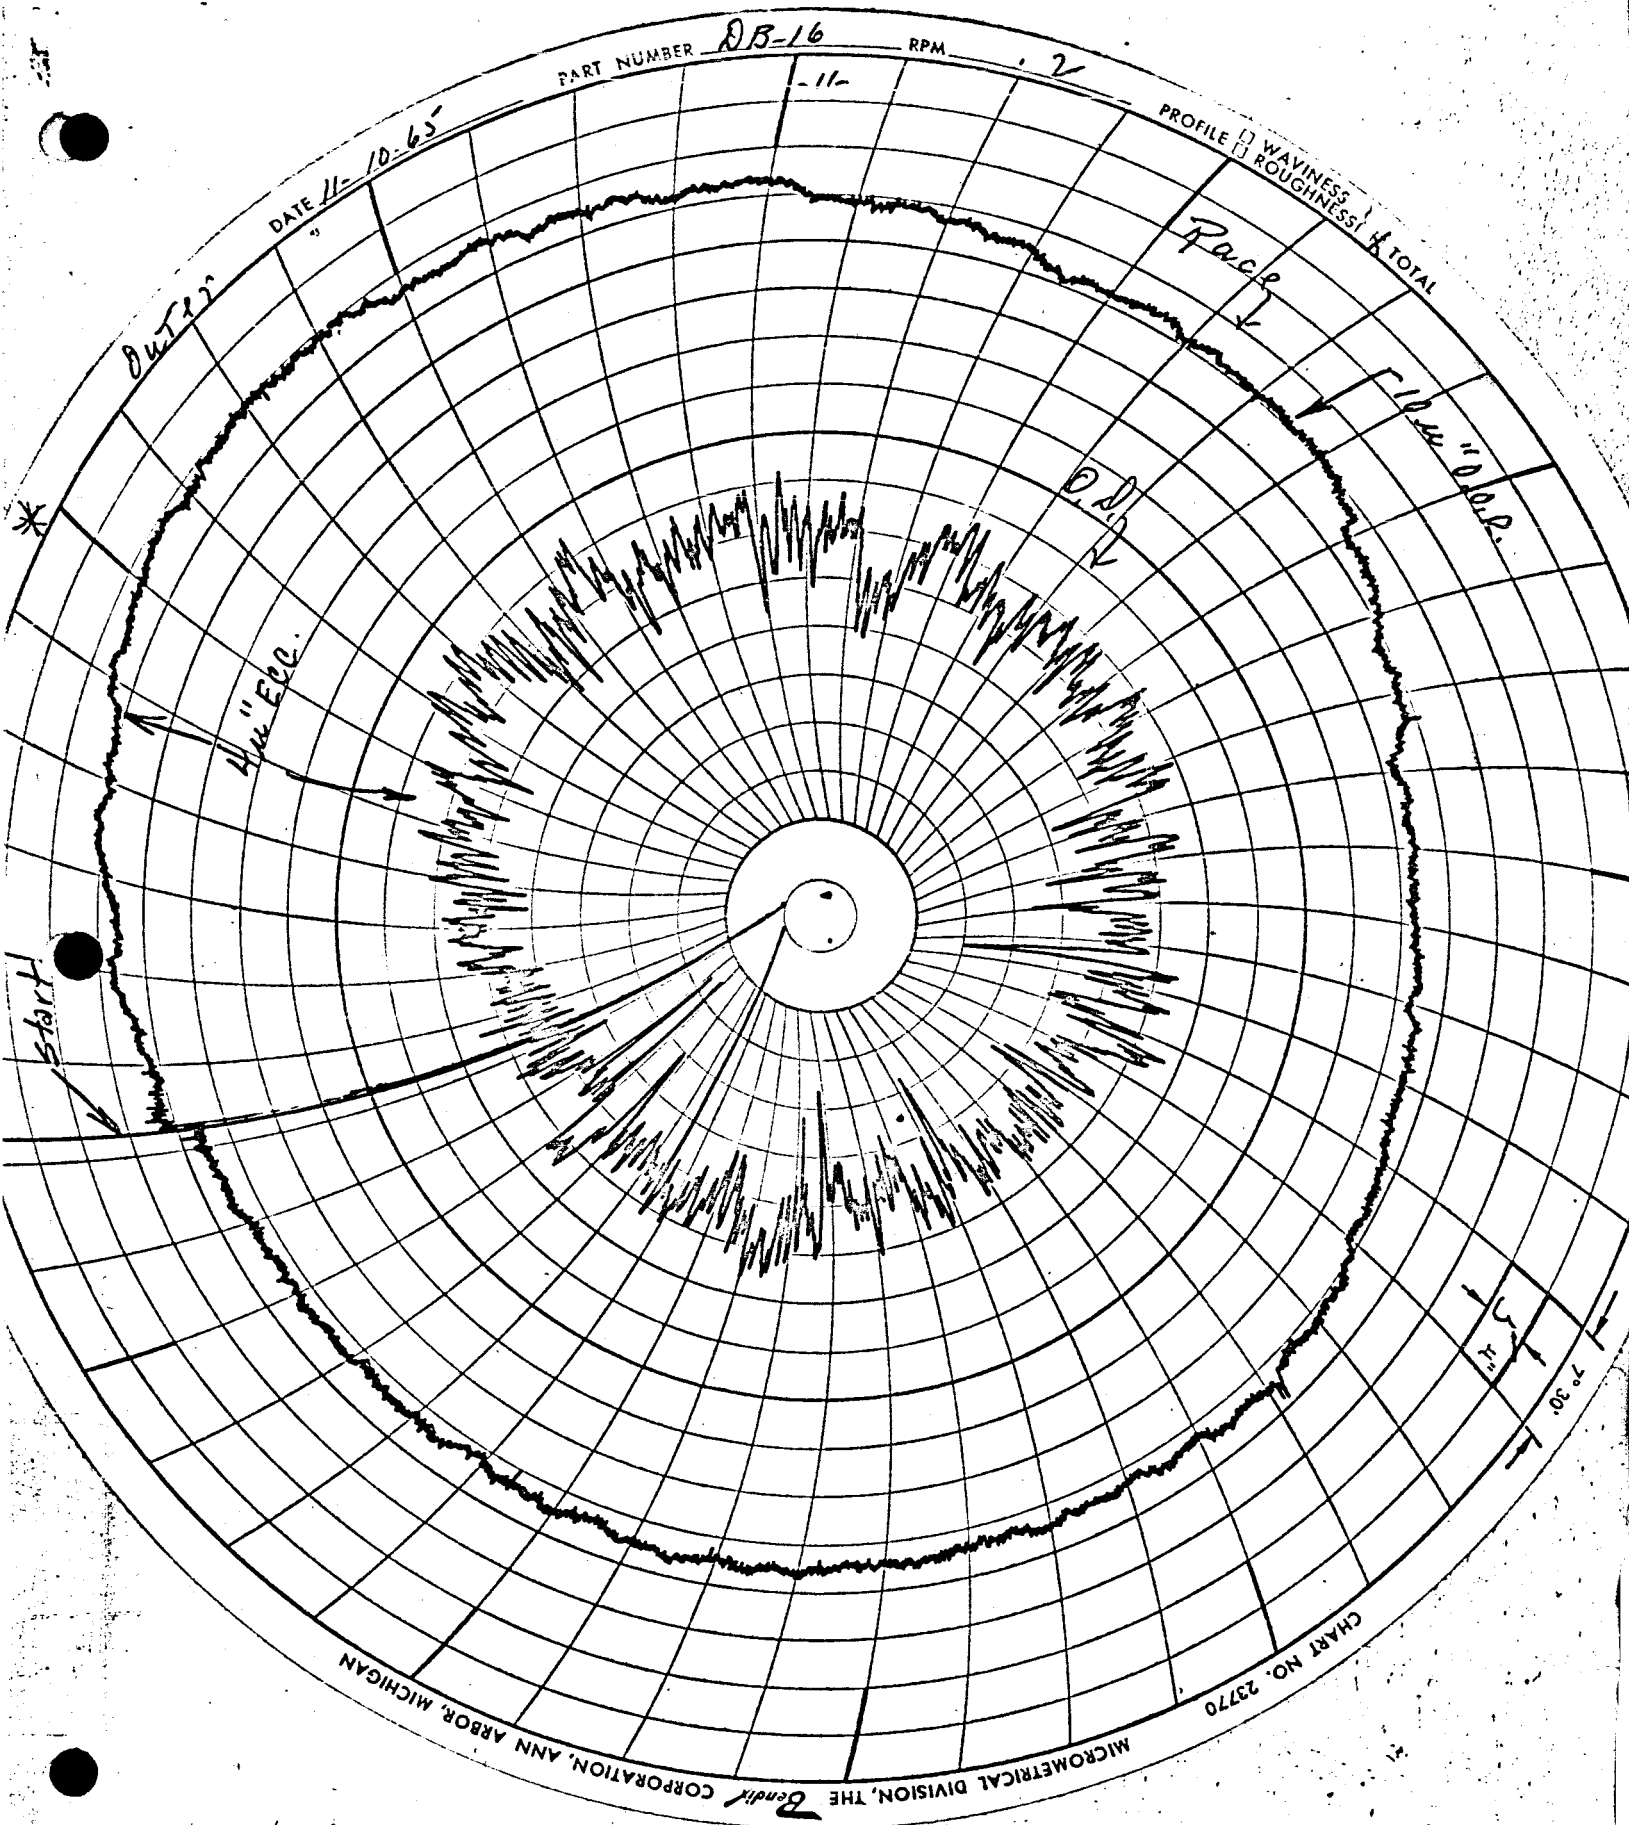
PROFICORDER TRACES OF AN OUTER RACE AND OF O.D. OF
OUTER OF LOT DB, BEARING NO. 16

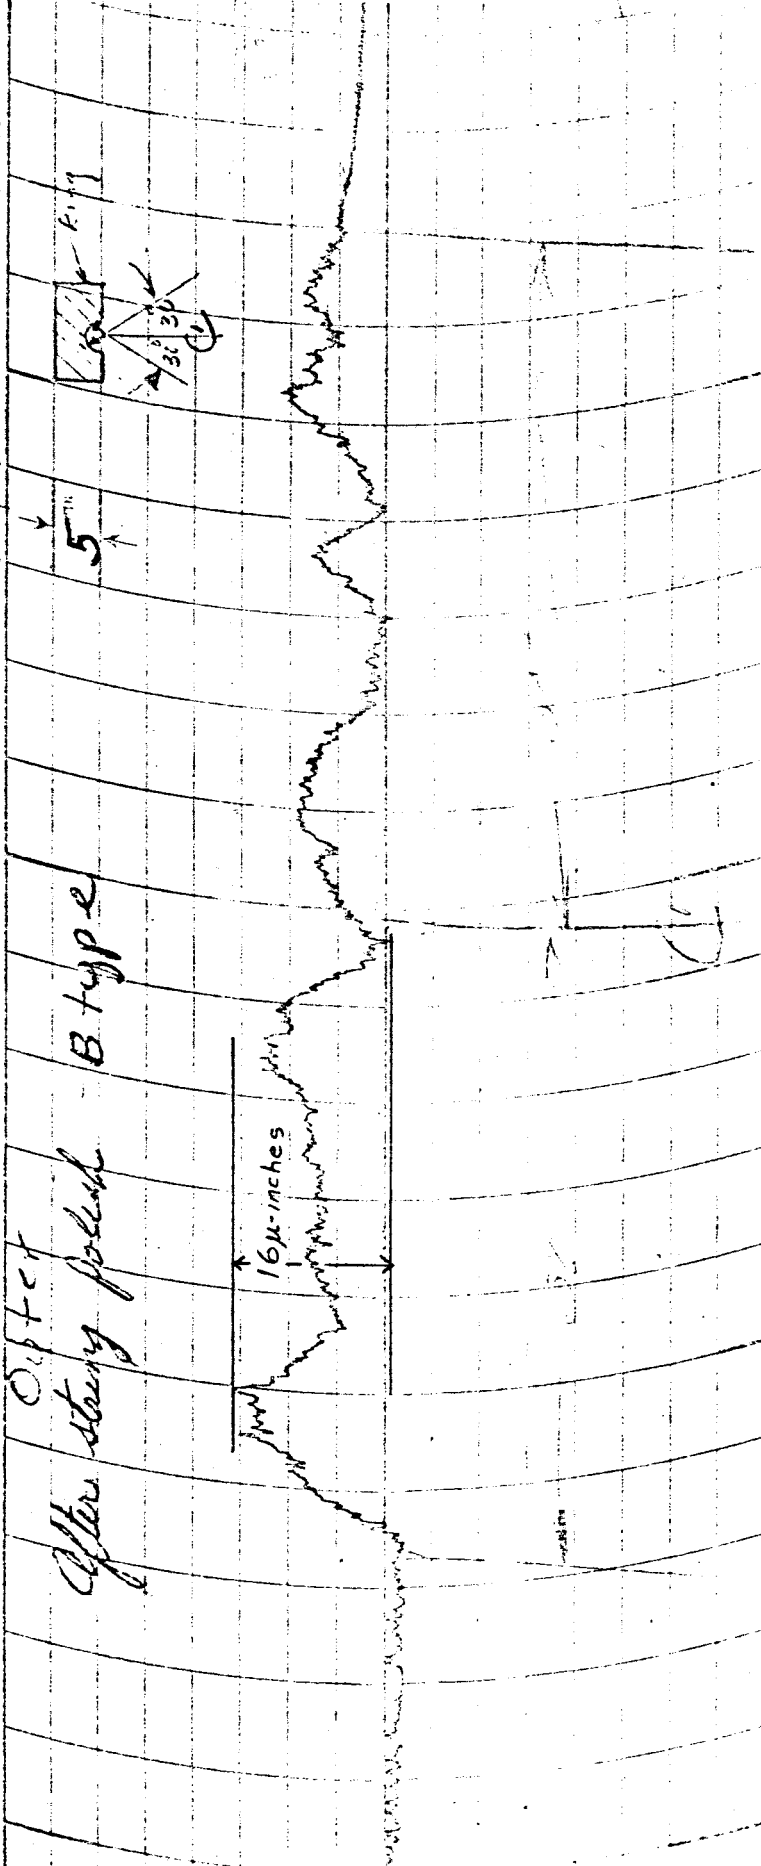
PROFICORDER TRACES OF FINISH OF OUTER RACE OF LOT DB

C. AFTER "B" TYPE FINISH

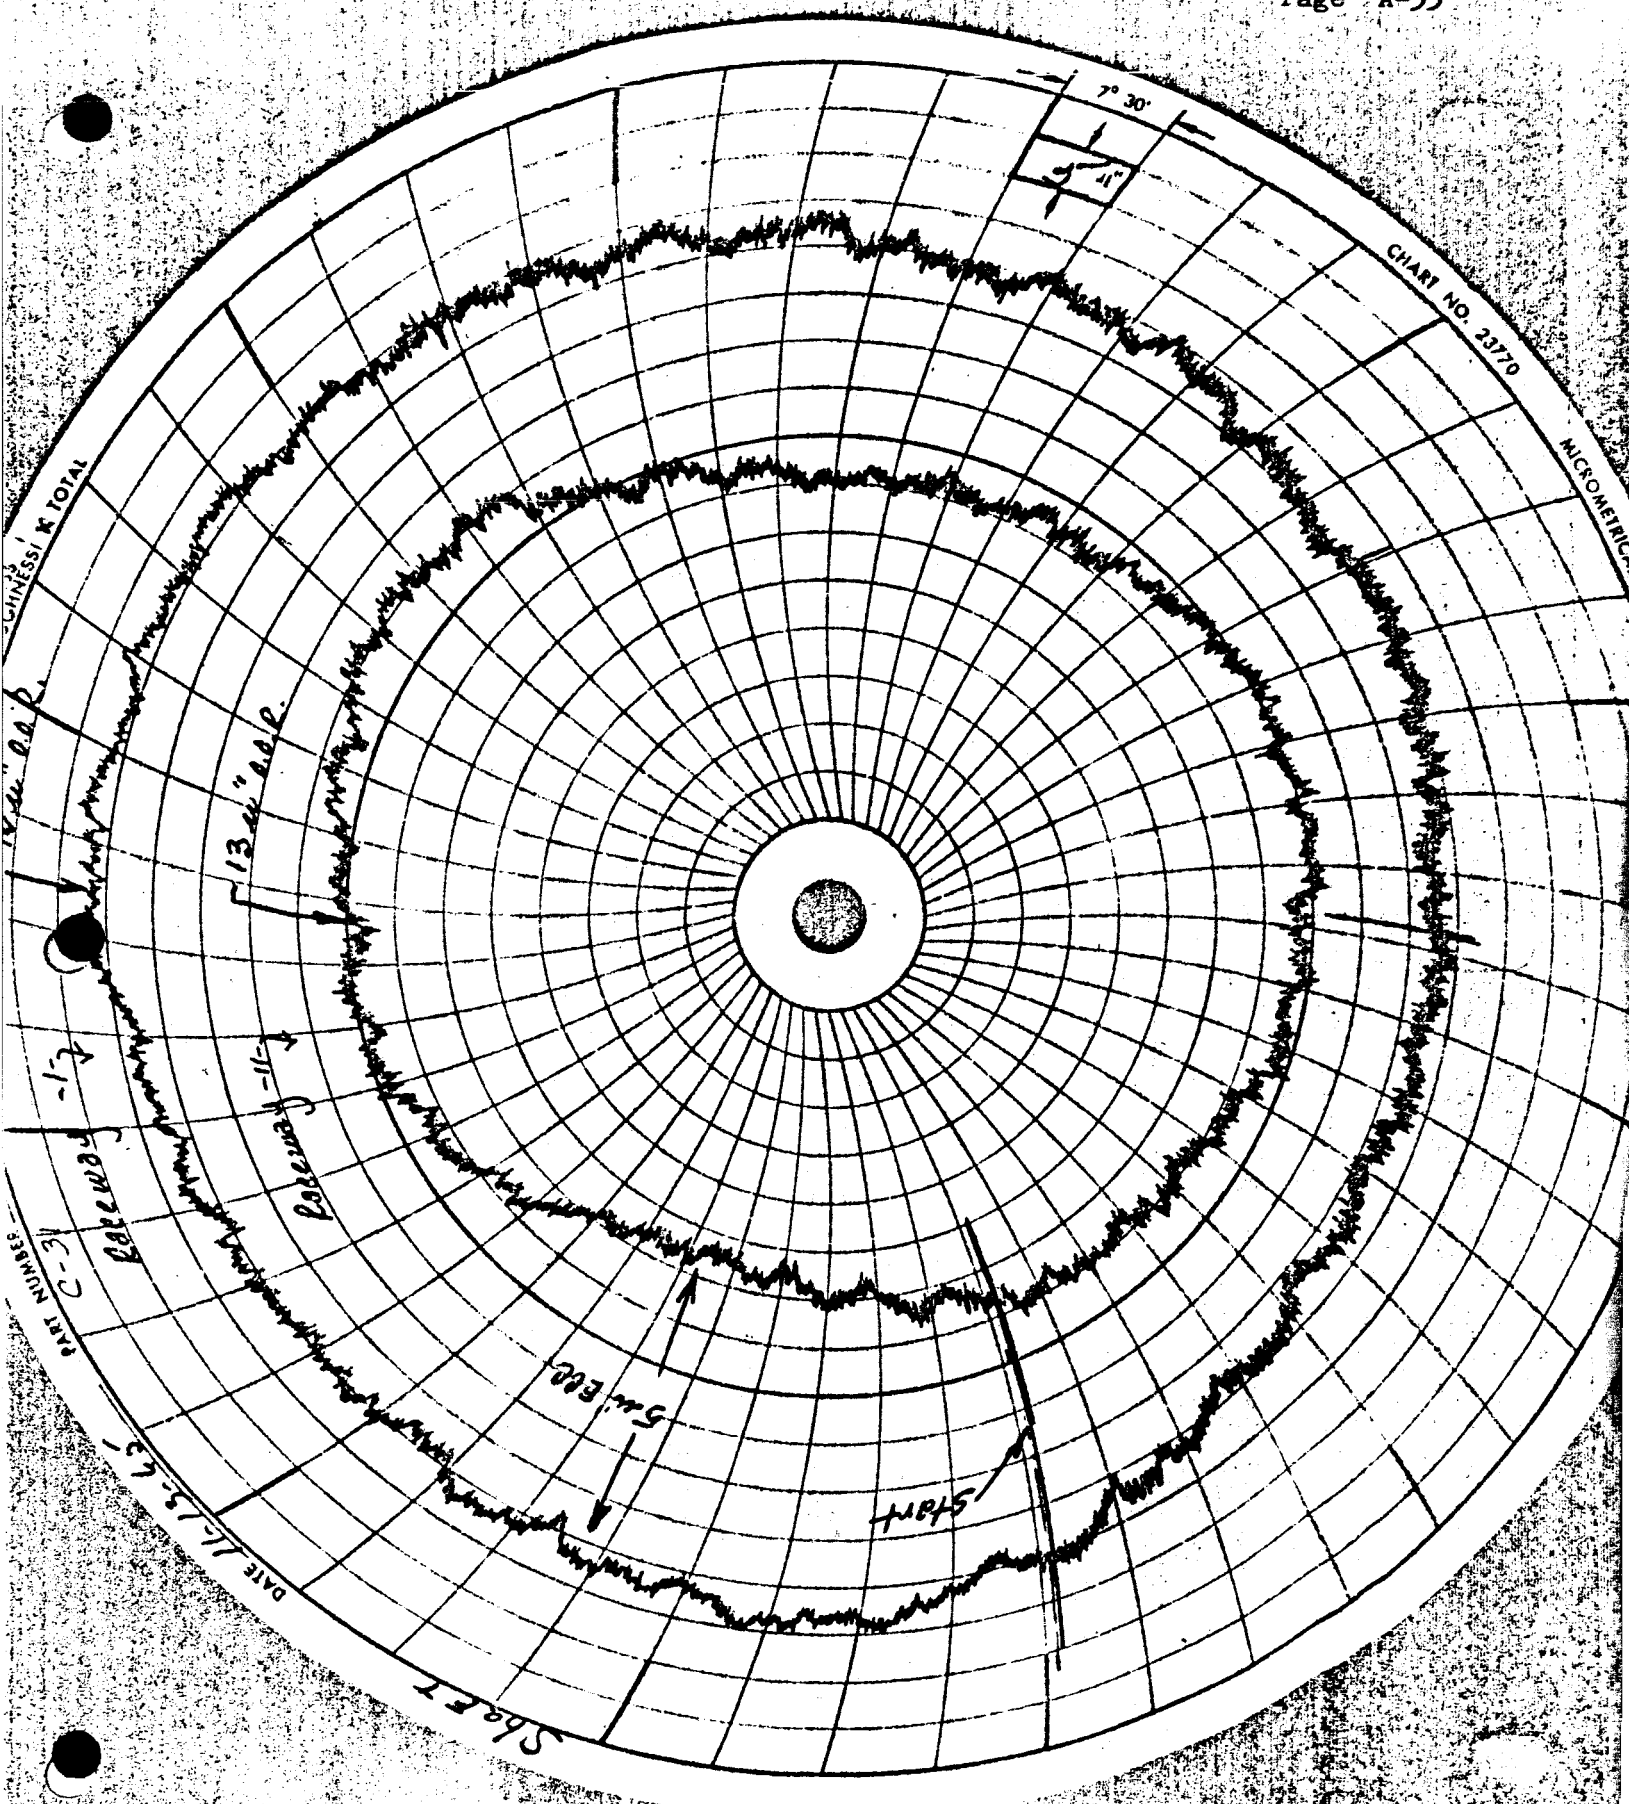
PROFICORDER TRACES OF INNER RACES OF LOT C-2, BEARING NO. 11

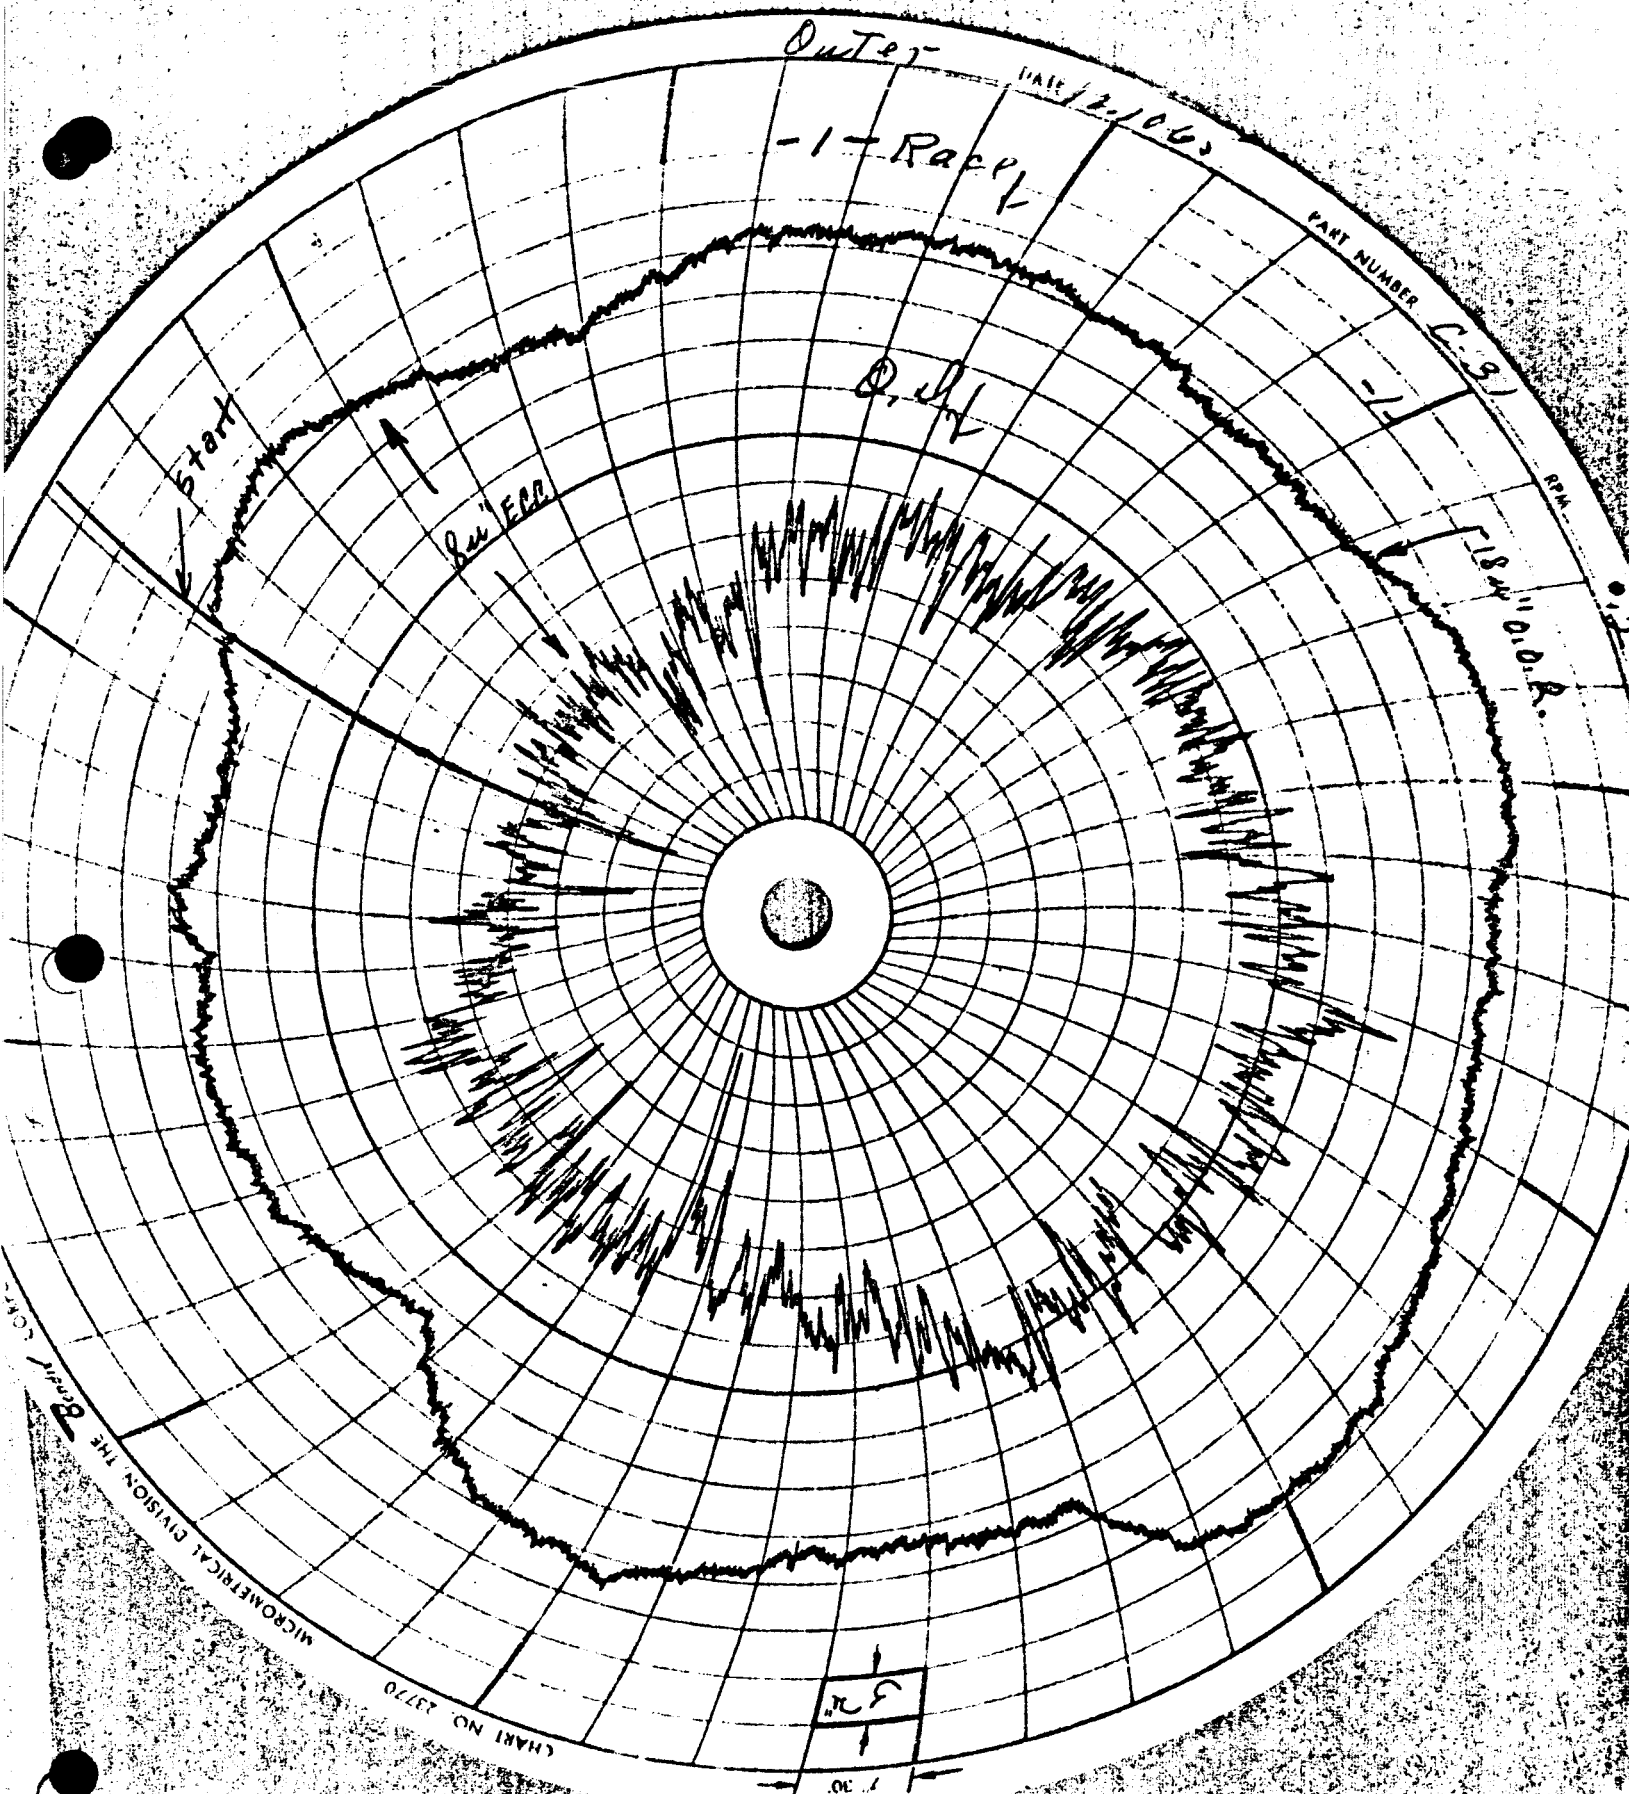
PROFICORDER TRACES OF AN OUTER RACE AND OF O.D. OF OUTER OF
LOT C-2, BEARING NO.31

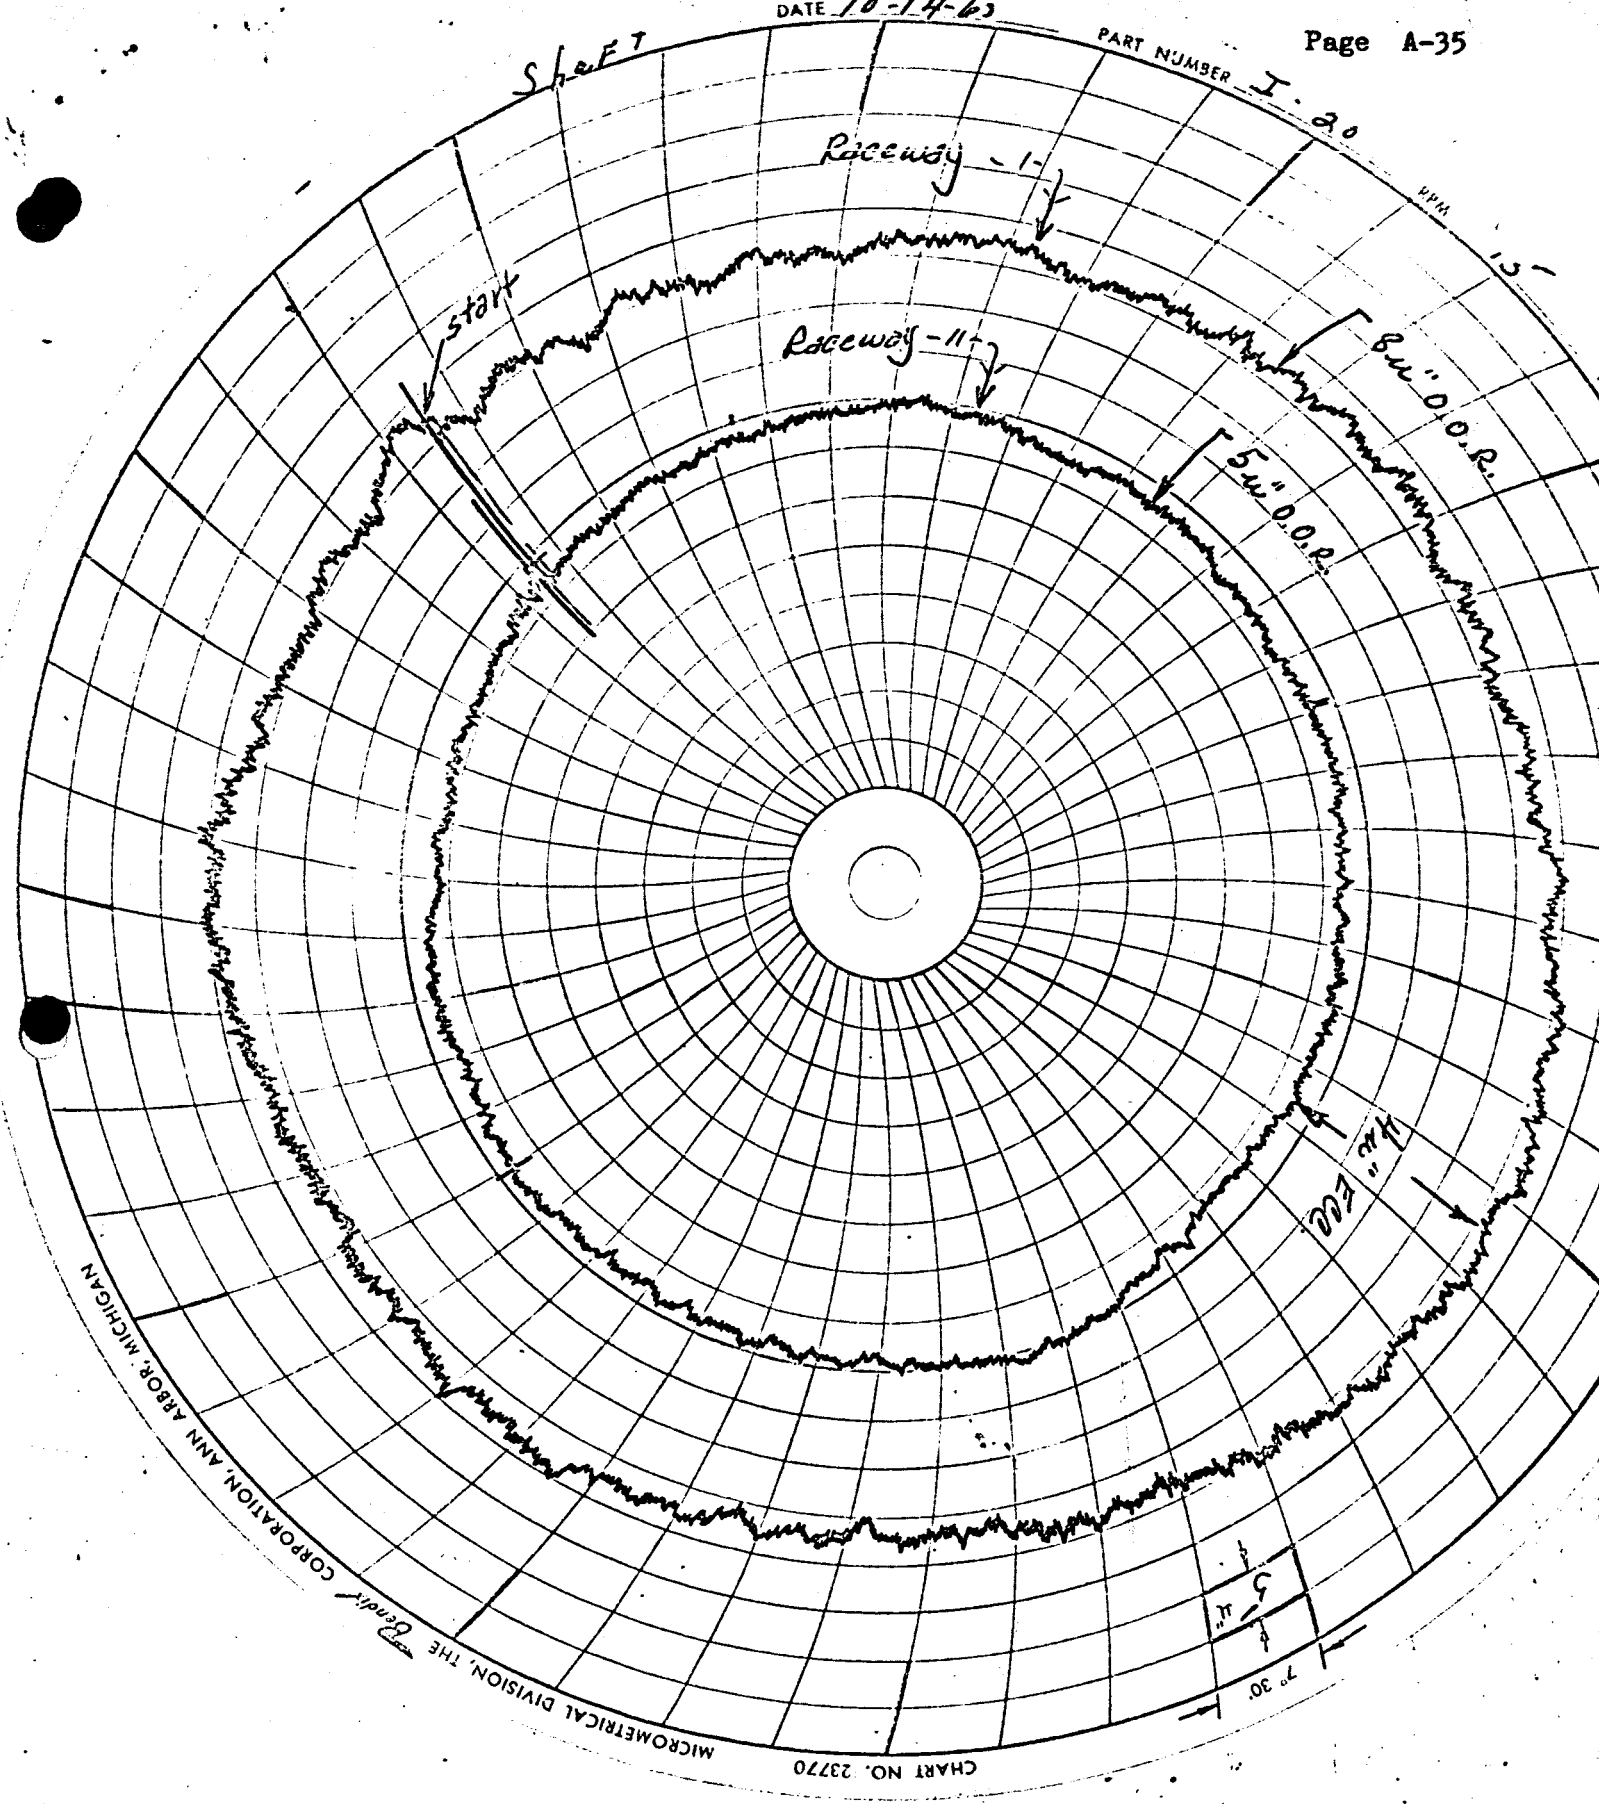
PROFICORDER TRACES OF INNER RACES OF LOT I-2, BEARING NO. 20

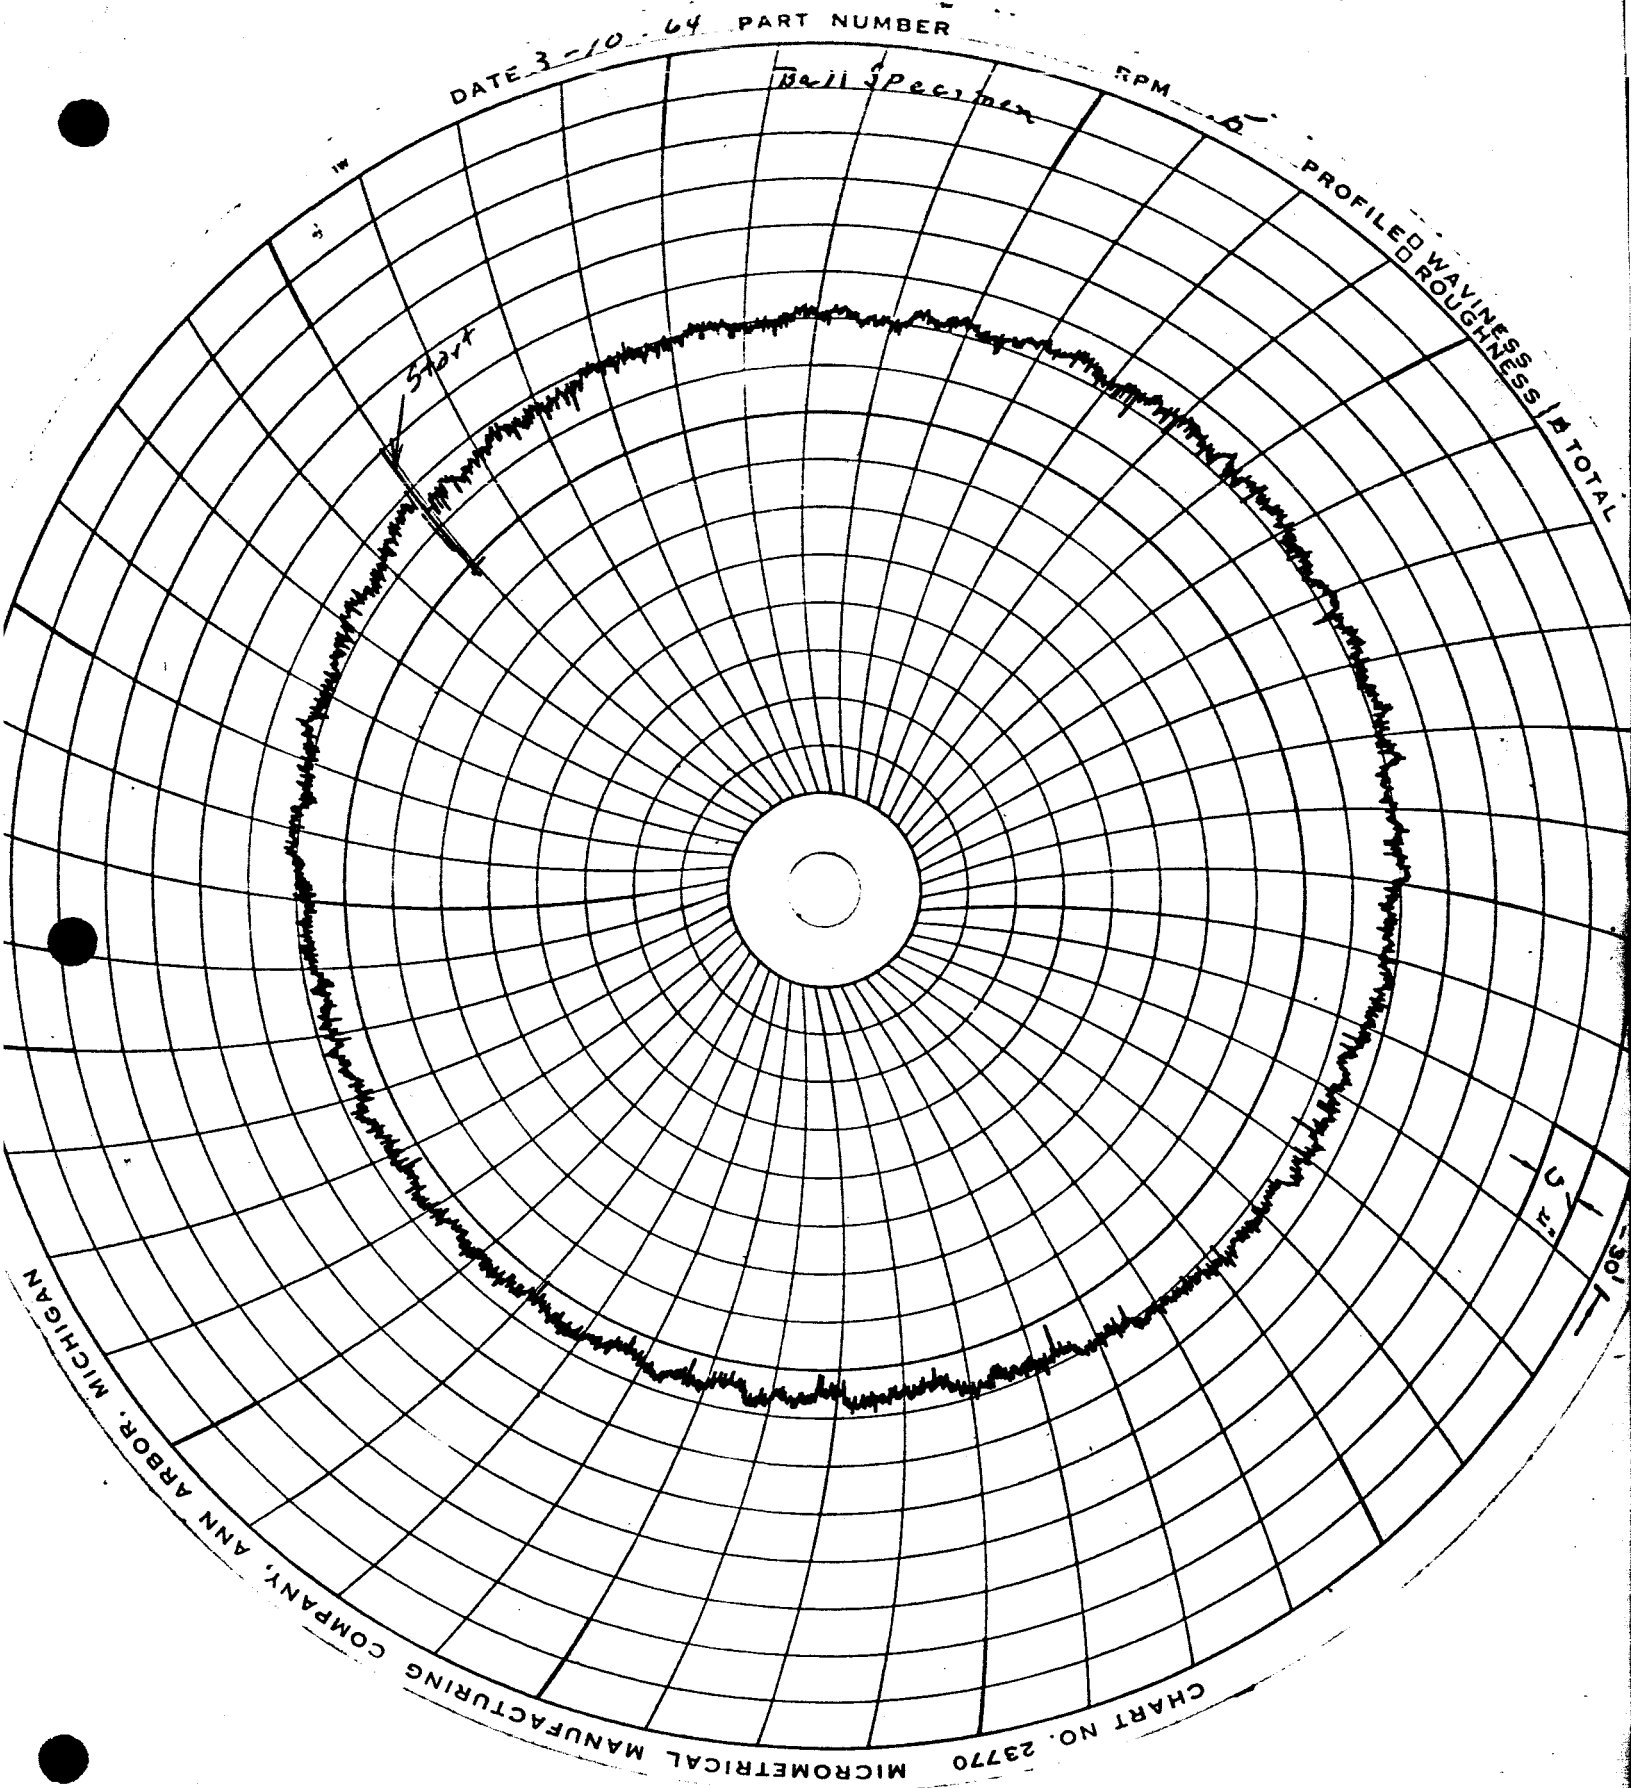
PROFICORDER TRACE OF MASTER BALL AFTER CHECKING OF LOT B

amplification up to 50,000X and has become Marlin-Rockwell Company's standard instrument for final check-out of waviness and surface finish for both profile and circumferential measurements. To assure the reliability of this instrument, a 11/32" diameter ball was set aside and checked on the Proficorder after the measuring of each lot of bearings. It was found that instrument noise and lack of resolution tend to obscure the tiny differences between specimens. In addition, the continuing checks of the "Master Ball" reveal variation in Proficorder signal for the same input.
